On Friday July 24, 2015, I attended a static loading test at 1047 Commonwealth Ave. in Brookline (Boston) performed on a 40 ft pile equipped with an expanded or enlarged toe ("Expander Body Incotec"). The test was performed by HUB Foundation Co. of Chelmsford, Massachusetts.

The purpose of this letter is to report on the results of the test.

!. The Expander Base Incotec, EBI

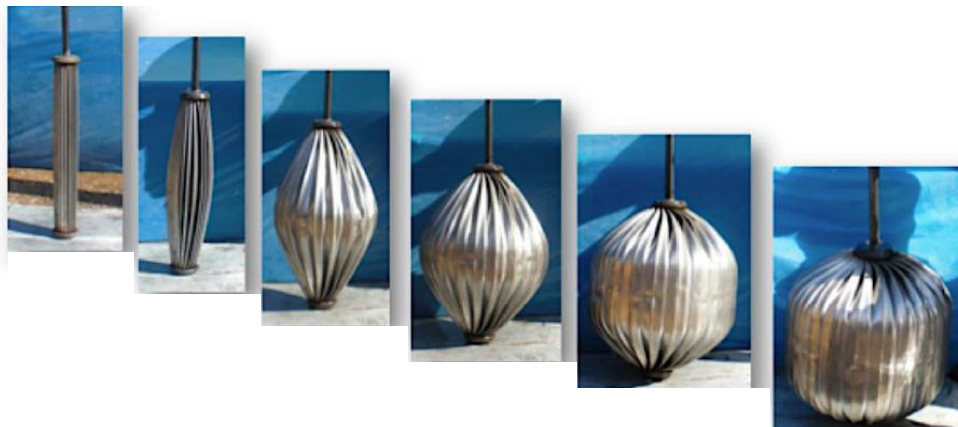
The Expander Body Incotec, EBI, consists of an initially about 5 ft high and 8 inch diameter cylindrical, folded steel tube body. After placing the EBI at the end of a small diameter steel casing, or end of a reinforcing cage in a bored pile, and inserting the EBI to a desired depth, it is inflated by injecting cement grout. The final shape is nearly spherical as shown in Figure 1.

Figure 1. The EBI before, during, and at end of the inflation procedure

The lateral expansion of the EBI causes the EBI to reduce its height. Tension forces will therefore develop between the EBI and the lower portion of the casing or pile. The connection between the EBI and the pile is therefore prepared with reinforcing that prevents the damage due to the tension force. Moreover, the expansion-induced height reduction potentially results in a void below the EBI. This void is postgrouted a day or so after the EBI grouting to ensure the sound contact between the EBI and the soil below.

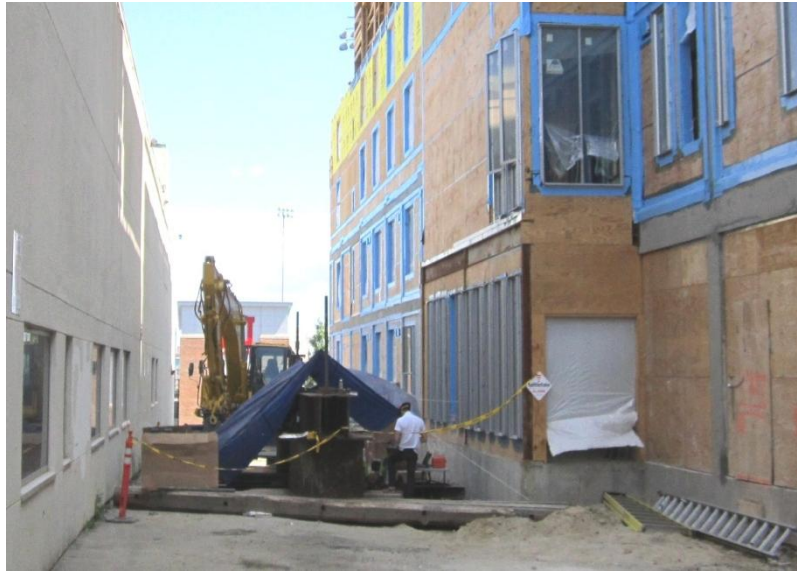
Figure 2. Photo of test site during ongoing static loading test

The loading test was performed in an alley between two existing buildings founded on piles. Figure 2 shows a photo of the site during the ongoing test. The soil profile was determined in three boreholes (borehole logs by Soil Exploration Corp. dated April 24, 2014). Figure 3 shows the distribution of SPT N-indices and soil profile, as determined from visual inspection of the split-tube samples. The EBI-equipped test pile is also indicated. The groundwater table was reported to be at 23 ft depth. As no water content or soil density values were provided, a total density of 125 pcf is assumed representative for the soil profile throughout.

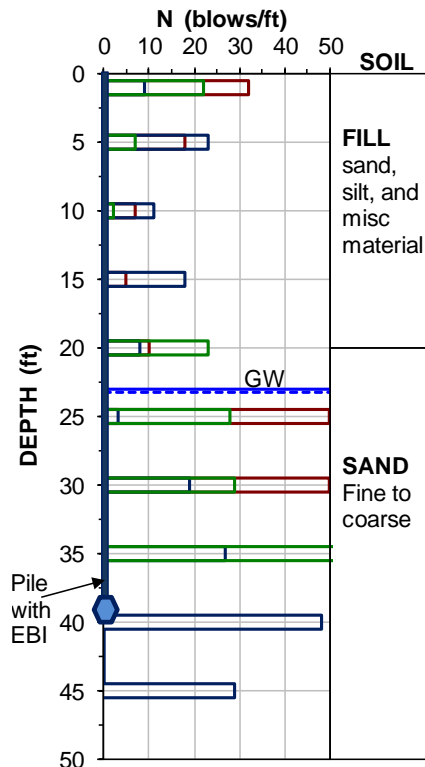
Figure 2. Soil profile and SPT N-indices

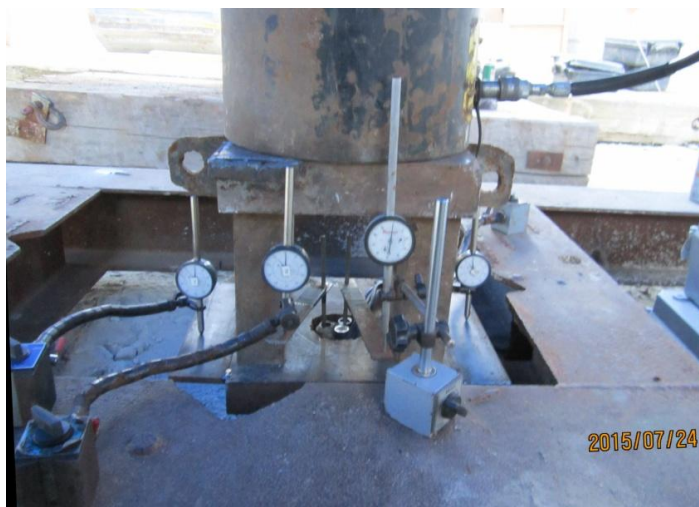
The static loading test was performed by jacking against a beam connected to the reaction piles installed prior to constructing the test pile placed about 8 ft on each side of the test pile. The pile head movement was measured using two dial gages and the telltale movements were measured using one dial gage for each telltale top. Figure 3 shows the telltale arrangement at the pile head. A load cell was used to measure and record the load applied to the pile head.

Figure 3. Arrangement of dial gages at the pile head

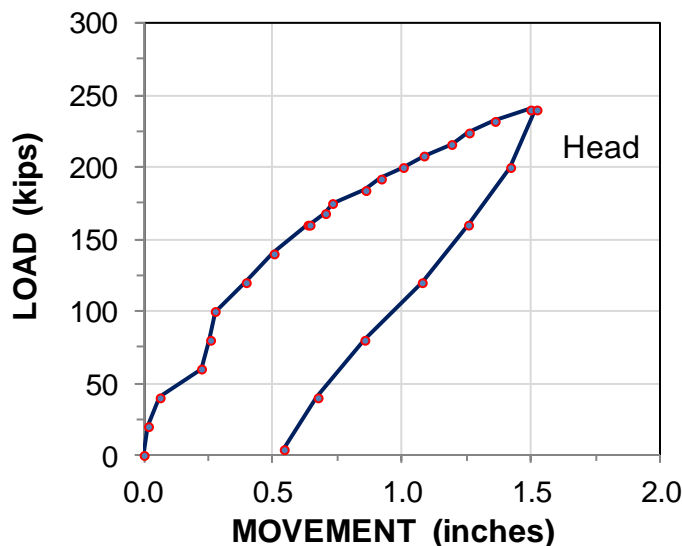
A tension test was performed on the pile on November 19, 2014, to a maximum load of 240 kips. The loading schedule consisted of a series of ten 30- kip increment applied every 30-minute with a 65-minute load-holding at the tenth load, followed by ten 15-kip increments to the maximum load of 240 kips, which was held for 90 minutes. Figure 4 shows the measured pile head load-movement for the tension test.

Figure 4. Pile-head load-movement of the tension test on the 54-ft pile

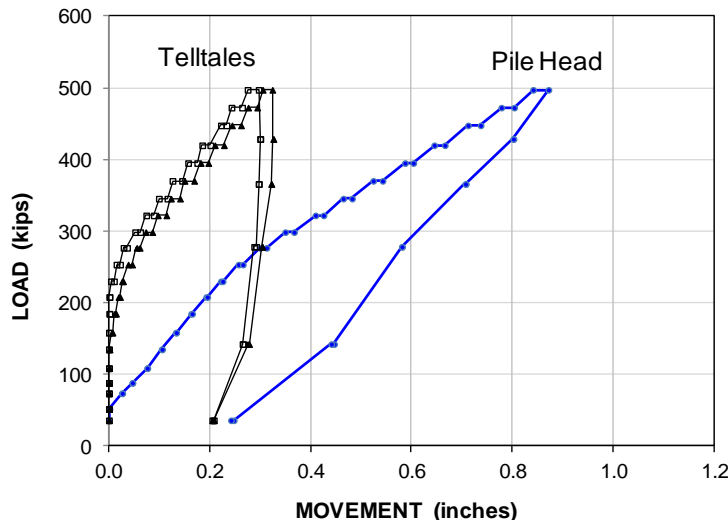
Figure 6 shows the pile-head load-movement curves and the pile-head load vs. the movement of the telltale tips at 35.8 and 38.3 ft.

Figure 6. Load-movements measured for the EBI pile

The static loading test on the EBI-equipped 7.0-inch casing showed that about 380 kips reached the EBI and generated a 0.3-inch movement. No failure, not even an incipient failure is indicated by the records.

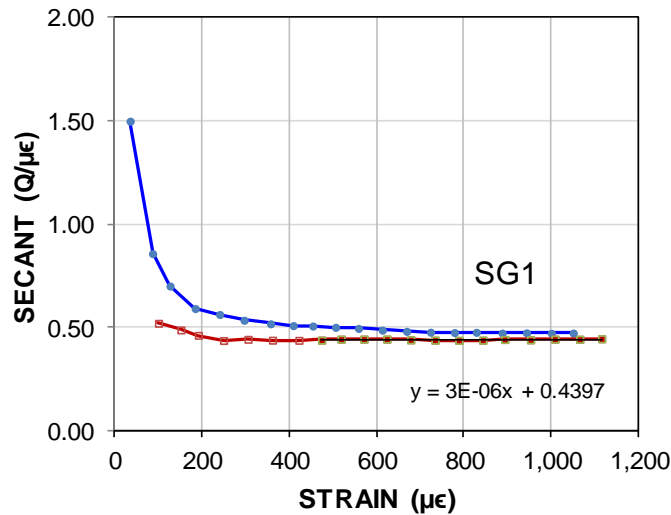
The 4 ft below the pile head position of strain-gage SG1 makes it possible to determine the pile stiffness using the secant method as shown in Figure 7. However, as indicated by the initial steep sloping curve, the loading and unloading due to the inadvertent placing of the main beam on the pile has affected the strain-gage pile response. Most of this effect can be removed by adding 65 µε to the strain measured for each applied load. This results in an apparent pile axial stiffness to 4,400 kips.

Figure 7. Secant stiffness for the Gage SG1

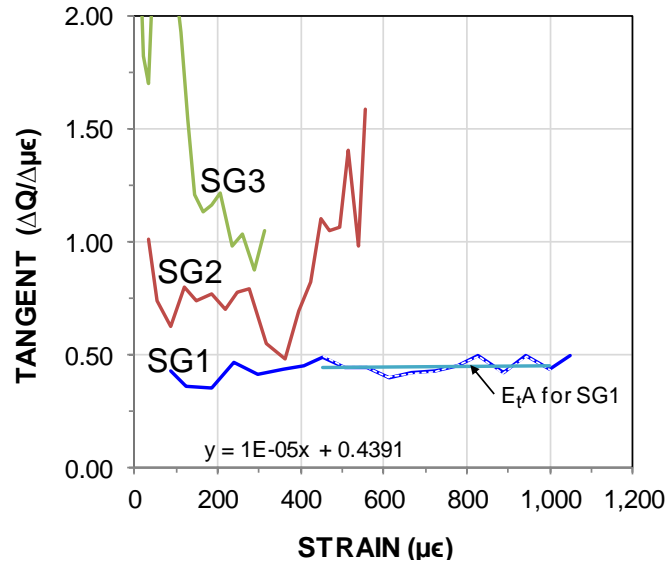
The alternative method to use is the incremental stiffness (tangent) as shown in Figure 8 and the stiffness indicated for SG1 is again 4,400 kips. Adjusting for 11.6 in² total steel area, the concrete modulus is about 4,000 ksi, which is representative for the confined conditions of the concrete inside the casing. (Applying a Poisson ratio 0.3, gives a Young's modulus of 2,900 ksi).

This method also applies to strain-gage positions further down the pile. However, Strain-gage SG2 gave erratic values and the records are considered unreliable. The strain-gage records were probably affected by the construction procedure (sloshing when the tremie pipe was emptied of water and when the casing was lifted of the EBI).

Strain-gage SG3 may be providing correct values of strain inside the EBI, but the conditions are certainly not representative for plane strain and the strain values have little analytical value.

Figure 8. Incremental (tangent) stiffness for the strain-gages

The strain-gage records of SG2 in the subject test pile were probably affected by the construction procedure (sloshing when the tremie pipe was emptied of water and when the casing was lifted off the EBI).

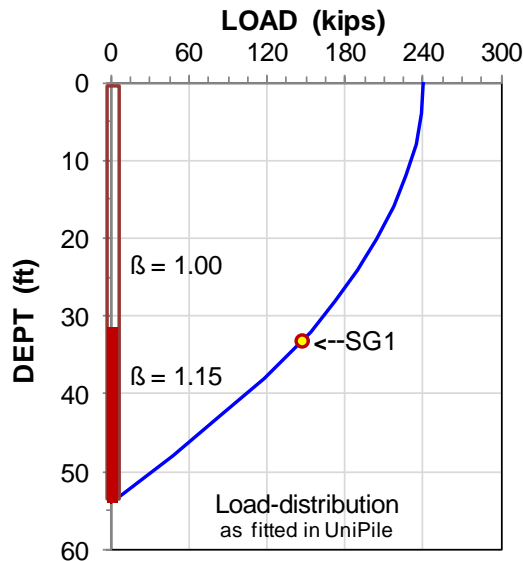
In general and, in particular, for piles in sand, the evaluation of pile response to load must be made applying effective stress analysis. The 240-kip maximum load of the 54 ft long tension test pile and the 143-kip load determined from SG1 at 33 ft depth results in back-calculated beta-coefficients of 1.00 for the upper length and 1.2 for the lower. The load distribution is shown in Figure 9.

Figure 9. Load distribution at maximum applied load in the tension test

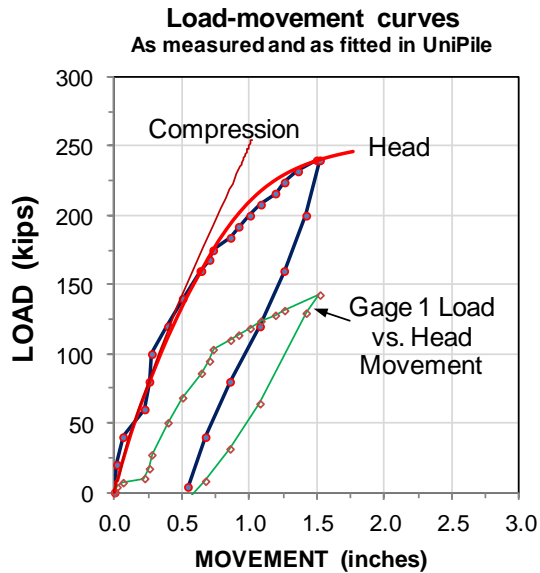
A simulation of the response was prepared using the UniPile software, applying t-z curves adjusted to make the calculated pile head movements fit the measured. The final fit was obtained by input of the same hyperbolic t-z function for the entire pile length performed using 2-ft pile elements and assuming 100 % mobilization of the input beta-coefficient for an element movement of 0.2 inch. The measured and simulated load-movement curves are shown in Figure 10. The UniPile calculations show an 1.00-inch pile compression, which means that the pile toe upward movement in the test was about 0.5 inch.

Figure 10. Load-movement curves as measured and as fitted in a UniPile simulation

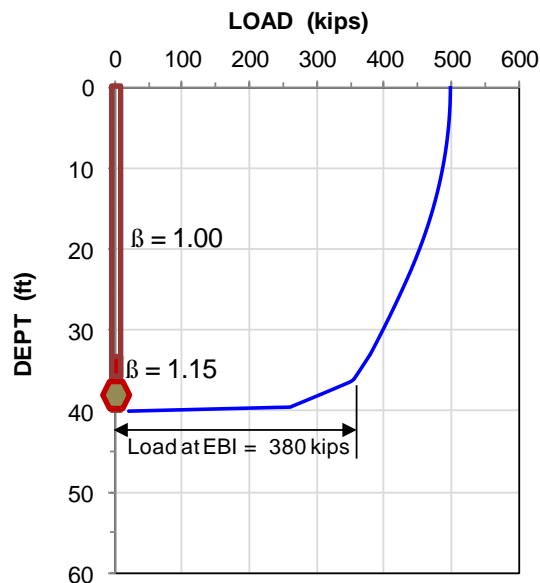
A similar effective stress analysis was performed on the results of the subject test using the same soil and shaft input as used in the fit to the tension test measurements with fitting the resistance at the top of the EBI so that same maximum load as applied in the test was obtained. The load-distribution calculated by UniPile is shown in Figure 11.

Figure 11. Load distribution at maximum applied load in the subject loading test

The analysis of the distribution of shaft resistance along the tension pile and the compression pile agreed well and the same beta-coefficient and the same t-z functions were used to fit the simulated test results to the measured for the two test.

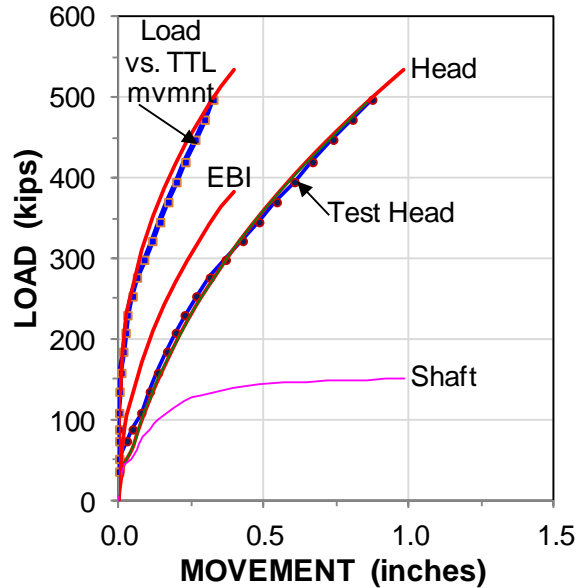
Keeping the same t - z functions and beta-coefficients as used for the fit of the tension test, the next UniPile analysis was made to fit the analysis also to the measured load-movement records, as shown in Figure 12. Note that not only is a good fit obtained for all of the pile head load-movement curve, the analysis also fits the telltale-measured movement above the EBI. This means that the curve marked "EBI" can be considered an accurate fit to the load at the top of the EBI for the actual 0.3-inch movement.

Figure 12. Subject test: Load-movement curves as measured and as fitted in a UniPile simulation
