EXPANDER BODY PILES RESUPPORT STRUCTURE

Anthony C. Barila, P.E., John R. McKinnon and Harry J. Berlis

INTRODUCTION

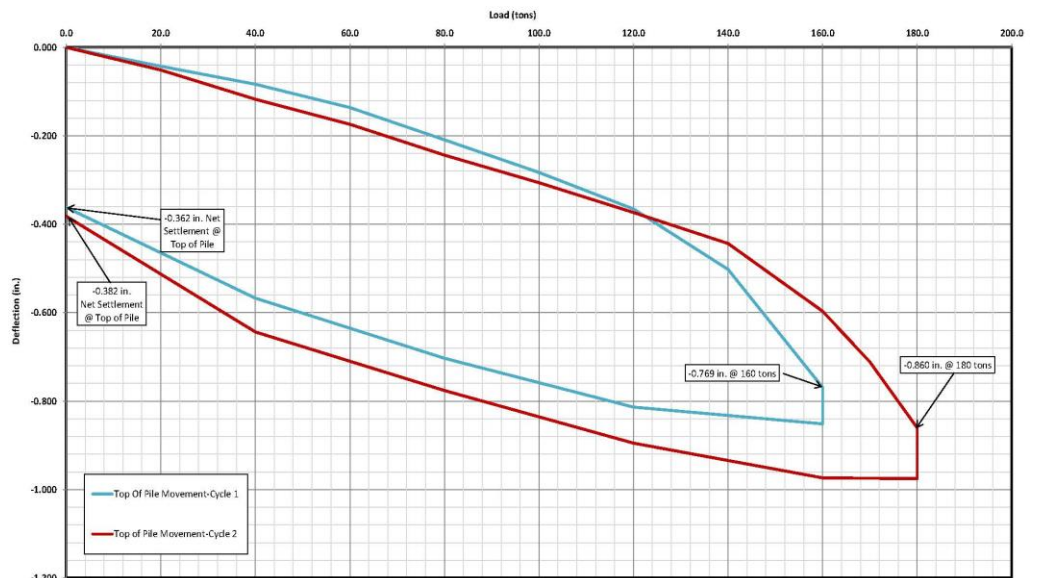
Figure 6: Settlement v. Load for Test Pile

Figure 6 provides a plot of settlement v load. Initially, the test pile was loaded to twice the highest design load (160 tons). After the creep rate was acceptable at this test load, it was unloaded to zero and reloaded to 180 tons. The purpose of the higher test load was to document that a higher design capacity could be achieved.

The top of the test pile showed a total movement of 0.769" and 0.860" at 160 and 180 tons, respectively. The net settlements were 0.362" and 0.382" at 160 and 180 tons, respectively. This is well below the code requirement of 0.50".

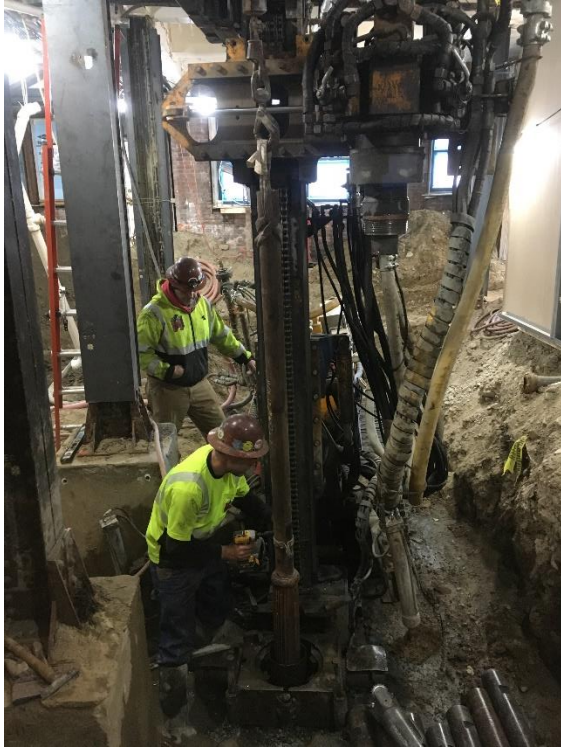
Photo 4: Drilling Next to Existing Columns

The EBs were installed within the basement of the condo building after extensive demolition and excavation to the top of the existing grade beams. The headroom within the structure after this preparatory work was completed ranged from less than 9ft to a maximum of 12 ft. Access into and within the basement was extremely difficult and was limited by the load bearing walls that had to remain fully intact. Refer to Photos 4 to 6 which show the difficult logistics within the basement.

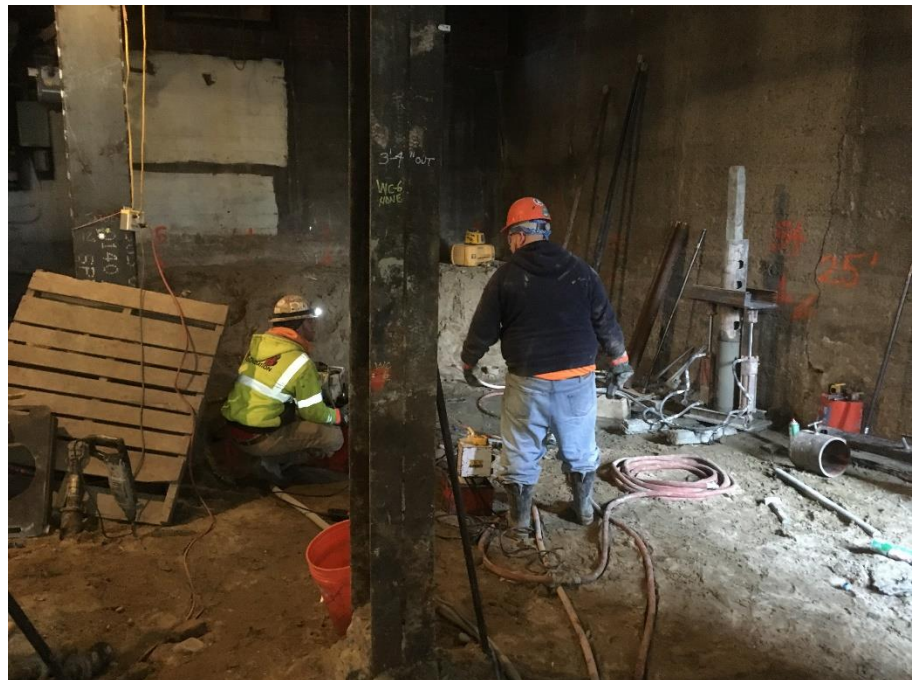
Photo 8: Hydraulic Casing Extraction Setup

To increase overall efficiency and to allow the drill rigs to focus on drilling only, a “jacking” device was developed by Hub for this project to extract the casing after the EB components were installed and the primary grouting was completed. This was done with a second crew which would lower the EB

down the casing using a hoist, also developed by Hub, which was fastened to the casing. Refer to Photos 10 and 11 which show this system in use. The tight access and difficult logistical challenge forced many operations to be performed manually as only one small bobcat could enter the building portal and maneuver through the work area safely.

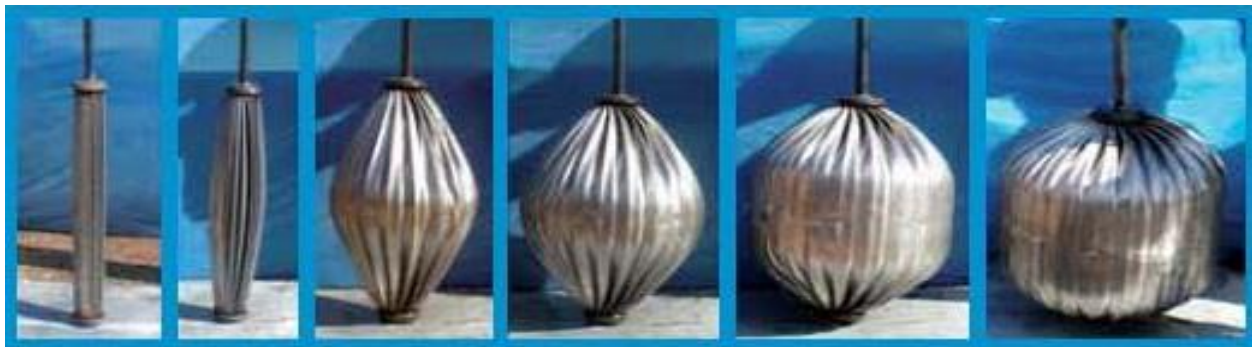
Figure 7: Phases of Expansion of the Expander Body Element

The Expander Body (EB) pile consists of a drilled pile with a folded steel section at the bottom that is expanded with cement grout injected under pressure. Refer to Figure 7 which depicts the expansion process. EBs are produced in three sizes: the EB 300, EB600 and EB 800. The EB 600 (600mm) was selected for this project to provide the required design capacities of 60 and 80 tons.

The EBs develop their capacity from a combination of end bearing at the tip of the expanded base and side friction along the sides of the expanded body. Note that the expansion process increases the density of the soils immediately around the EB. This was noted in this

project whereby successive piles required higher pressures to fully expand the EB. Also, the post-grouting process, in addition to filling any voids directly below the base of the EB, improves the density of the soils directly below the base of the EB via the injection of additional grout under pressure.
